Report on the A354 Grade BD High-Strength
Steel Rods on the New East Span of the
San Francisco-Oakland Bay Bridge
With Findings and Decisions

July 8, 2013

TOLL BRIDGE PROGRAM
OVERSIGHT COMMITTEE

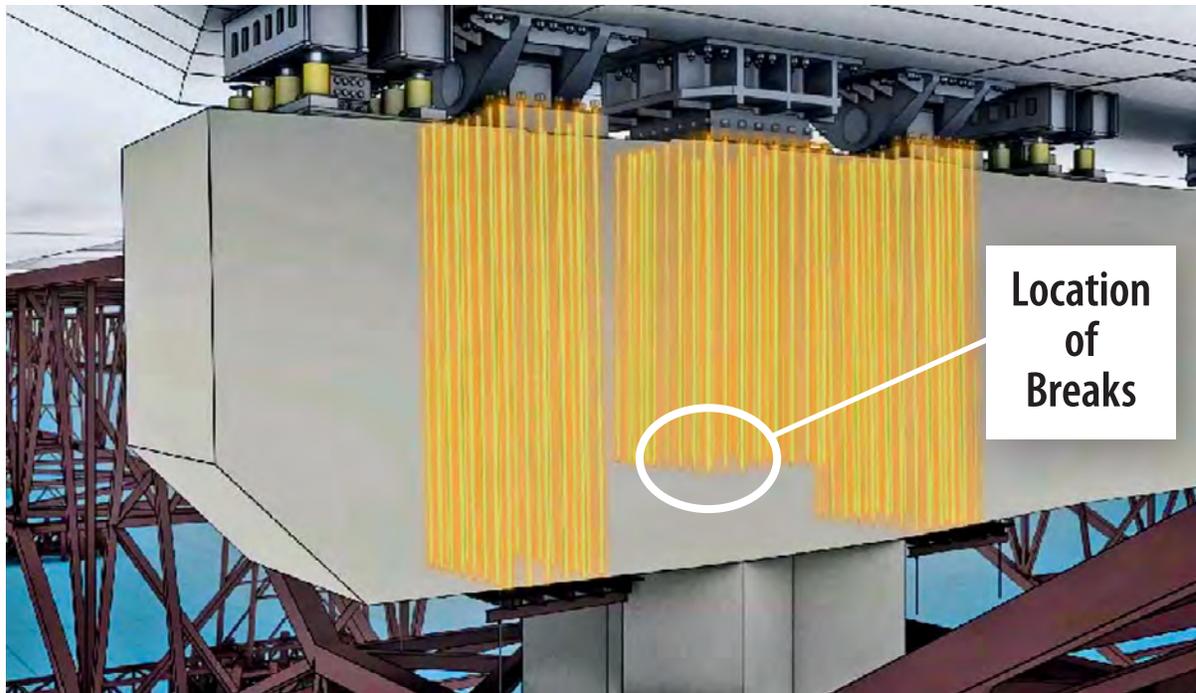
Figure ES-3: Location of Failed A354 Grade BD Anchor Rods

Between March 8, 2013 and March 14, 2013, 32 out of the 96 rods were discovered to have fractured. By March 14, 2013, Caltrans decided to lower the tension of the remaining unbroken rods from the 0.68 Fu to 0.45 Fu to avoid further fractures and to allow for investigation of the cause of the failures. The tension level was reduced on all unbroken rods. If the tension had not been reduced, it is possible that more of these 2008 high-strength steel rods at shear keys S1 and S2 would have fractured.

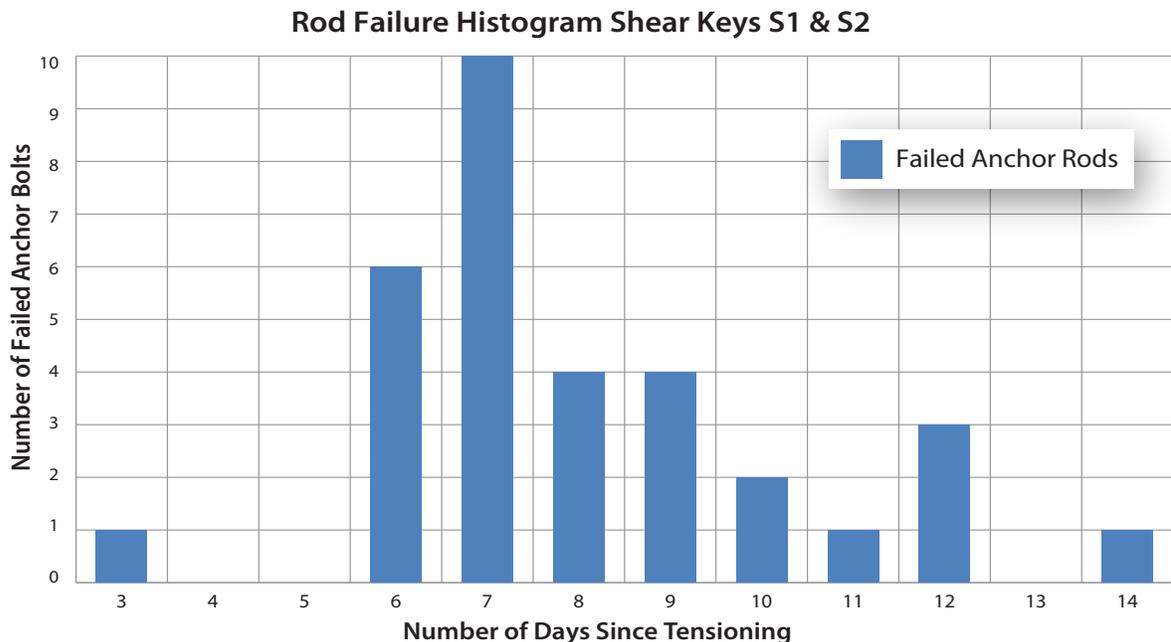
Figure 6 Timeline of 2008 Anchor Rod Fractures After Stressing*

* The time axis shows the number of days after tensioning each individual rod was discovered fractured. Note that the tension in all non-fractured rods was reduced to 0.45 Fu after 14 days.

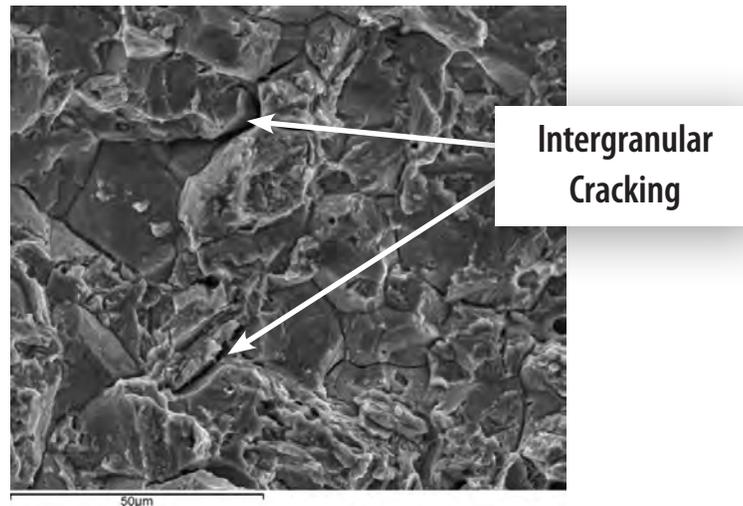
Figure 9 SEM Image of Rod S1-G1 Showing Intergranular Fracture Features

2 Scanning Electron Microscopy (SEM): Following visual observations, the fracture surfaces were examined at high magnification with a scanning electron microscope (SEM). Figure 9 is an SEM image of Rod S1-G1 at high magnification, which shows intergranular cracking at, and near, the crack origin. Intergranular cracking is a characteristic feature indicative of a number of brittle fracture mechanisms, including hydrogen-assisted cracking.

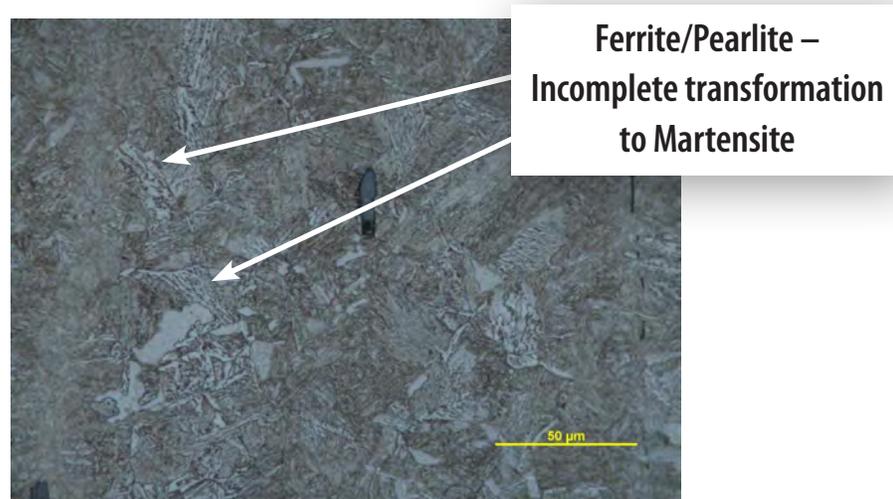
Figure 10 Microstructural Examination Indicating Non-Homogeneous Material

3 Microstructural examination: Following the SEM examination, cross-sections were cut from both rods and metallurgically prepared to examine the structure of the steel on a microscopic scale. The results of this examination (Figure 10) indicate the material is not homogeneous (i.e., not uniform in metallurgical structure across the examined sample of rod), as evidenced by the presence of ferrite and pearlite in between layers of martensite.

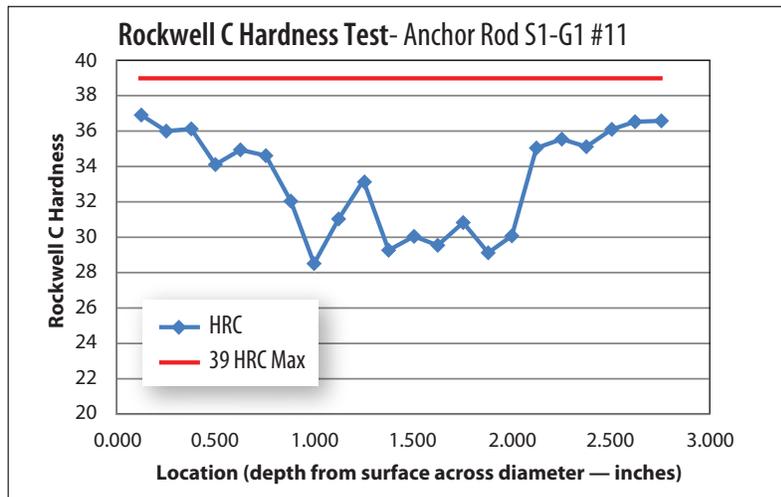
Figure 11 Rockwell Hardness Test Results — Rod S1-G1

4 Hardness testing: The Rockwell C hardness test is a technique that assesses a material's tensile strength, wear resistance and ductility. Samples were machined at Christensen Materials Labs and tests were performed in Hayward, California by Anamet Inc., where Rockwell C hardness measurements were made across the diameter and at mid-radius locations of both rods. Figures 11 and 12 illustrate the results of the Rockwell hardness tests conducted on Rod S1-G1 and Rod S2-A6, respectively. The results of the Rockwell hardness test show variation in hardness, with the outer diameter approaching 39 HRC (high hardness is generally considered greater than 35 HRC). The center hardness drops to as low as 25 HRC, indicating the material was not uniformly through-hardened. The metallurgical report states that completely uniform through-hardening is difficult to achieve in large diameter rods such as these; however, the large disparity in hardness from center to edge indicates that the steel may not have had optimal through-thickness hardenability or was improperly heat-treated. ASTM A354 for grade BD specifies a maximum rod hardness of 39 HRC, as shown by the solid red line in Figures 11 (Rod S1-G1) and 12 (Rod S2-A6).
