Report on the A354 Grade BD High-Strength
Steel Rods on the New East Span of the
San Francisco-Oakland Bay Bridge
With Findings and Decisions

July 8, 2013

TOLL BRIDGE PROGRAM
OVERSIGHT COMMITTEE

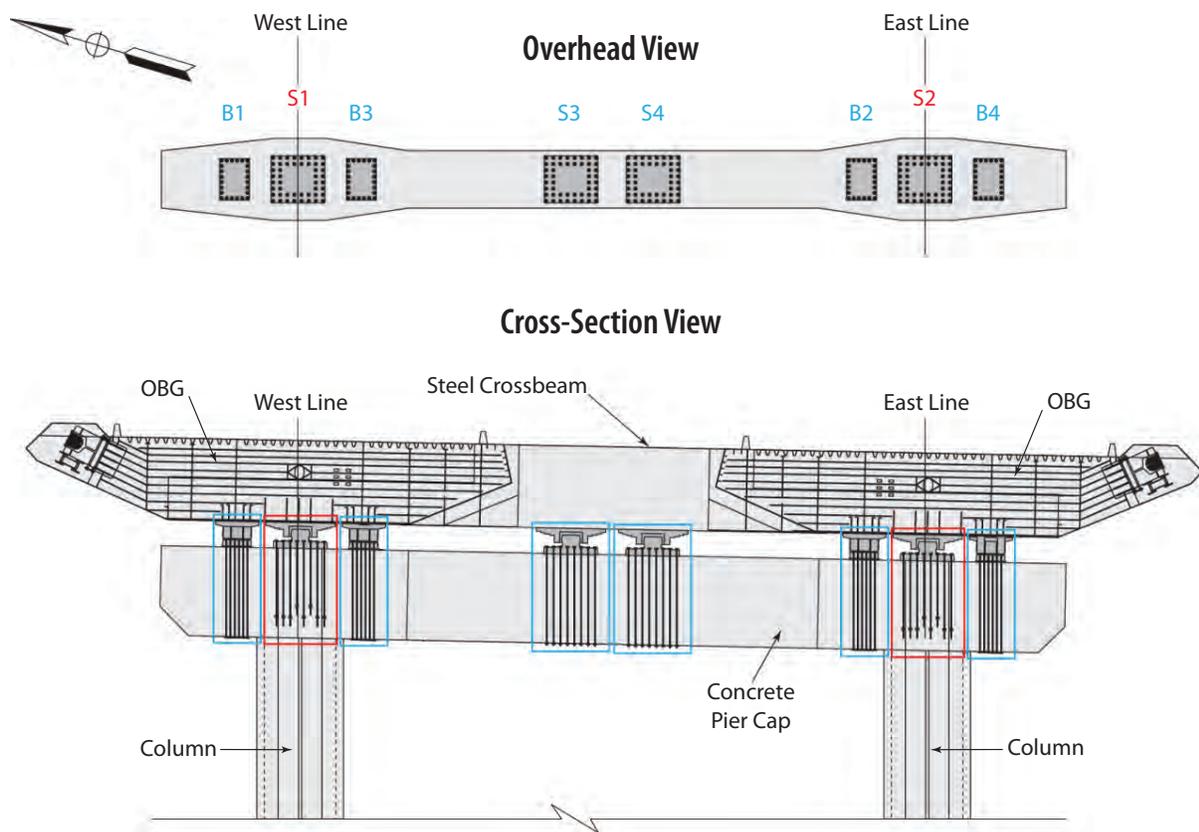
Figure ES-2 Bearings (B1-B4) and Shear Keys (S1-S4) in Pier E2

Ninety-six (96) high-strength steel rods are installed on the lower housing of shear keys S1 and S2 (Item #1 in Table ES-1) at Pier E2. These rods were fabricated by Dyson Corporation in Ohio between June 4, 2008 and September 6, 2008 and installed by American Bridge/Fluor Joint Venture, the bridge contractor for the SAS Bridge, in October 2008. Figure ES-2 illustrates Pier E2 and the location of the shear keys, bearings, and their high-strength steel rods. Figure ES-3 shows the location of the fractured rods.

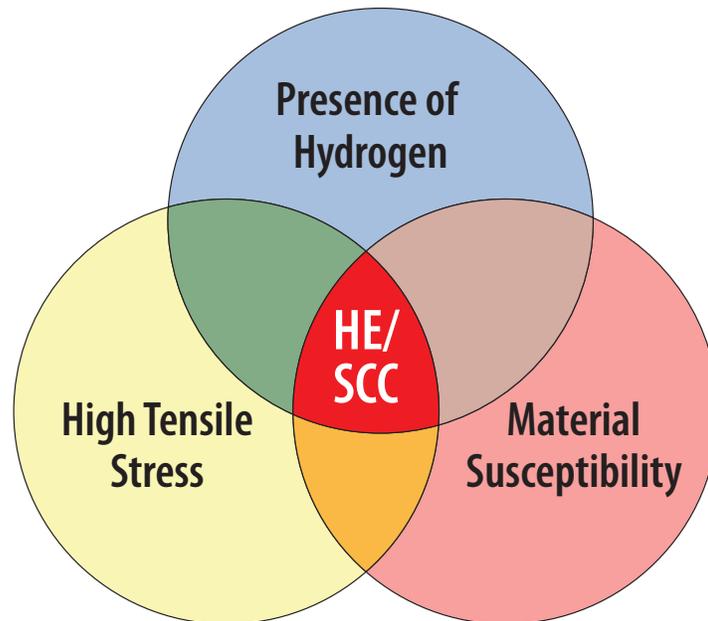
Figure ES-4 Causes of Hydrogen Embrittlement (HE) or Stress Corrosion Cracking (SCC)

Hydrogen embrittlement is the root cause for the failure of the A354 grade BD high-strength steel anchor rods at shear keys S1 and S2 (Item #1 in Table ES-1). As used in this report, hydrogen embrittlement is considered a short-term phenomenon that occurs in metals, including high-strength steel, when three conditions apply: a susceptible material, presence of hydrogen and high tensile stress (as shown in Figure ES-4). To trace what led to the rod failures, this summary calls out each of the three hydrogen embrittlement conditions, and then tracks the events and decisions that either caused or contributed to that condition. In their totality, these events and decisions led to the failure of the 2008 A354 grade BD rods in March 2013.

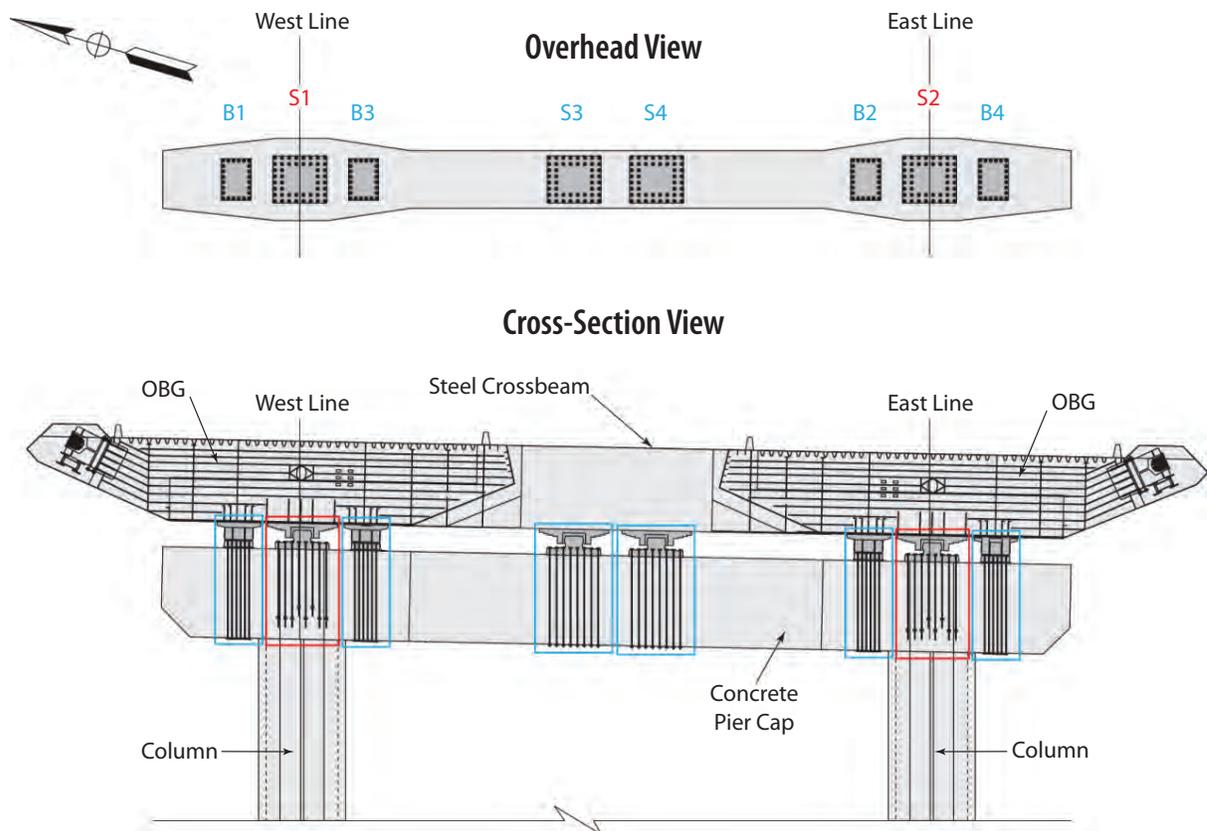
Figure 3 Bearings (B1-B4) and Shear Keys (S1-S4) in Pier E2

Because of the location of shear keys S1 and S2, directly over the Pier E2 support columns, the design developed by the T.Y. Lin International/Moffatt & Nichol Design Joint Venture called for the rods to be embedded as the concrete pier cap was constructed. This rendered the lower portion of the rods and nuts inaccessible after installation. Figure 3 illustrates Pier E2 and the location of the shear keys, bearings, and their high-strength steel rods. Figure 4 shows the location of the fractured rods.

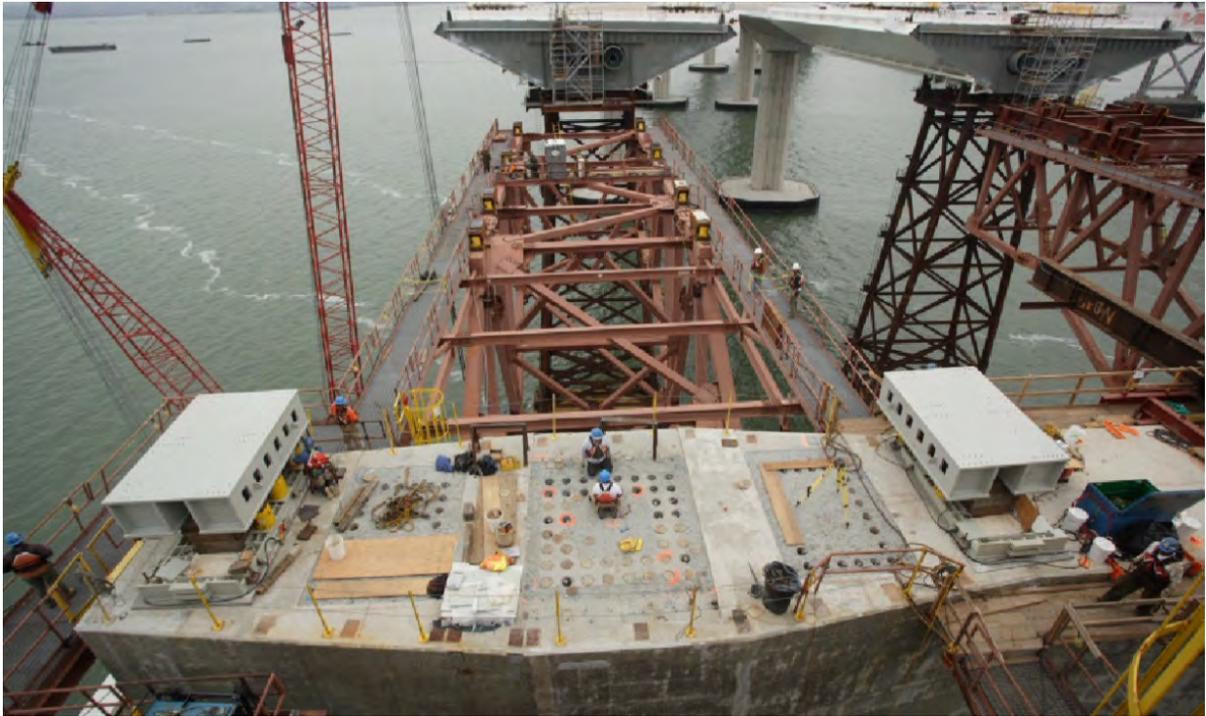
Figure 5 E2 Pier Cap Construction —
 (Center of photograph is the location of future shear key S1)

The E2 pier cap, including the embedded 2008 shear key anchor rods, was completed by early 2009. Due to the extended construction schedule, Pier E2 was completed three years before the roadway boxes were erected in place over the pier. This resulted in the anchor rods being exposed to the environment for an extended period of time before the next construction stage, which would tension and grout them in place. This open environment is shown in a Pier E2 construction progress photograph (Figure 5) taken soon after completion of the pier cap. There were no provisions made in the design by the T.Y. Lin International/Moffatt & Nichol Design Joint Venture or the installation procedures prescribed by American Bridge/Fluor Joint Venture to include water drainage or sufficient rain protection to prevent the ingress and accumulation of rainwater or other moisture in the anchor rod housings during this extended period.

Between March 8, 2013 and March 14, 2013, 32 out of the 96 rods were discovered to have fractured. By March 14, 2013, Caltrans decided to lower the tension of the remaining unbroken rods from the 0.68 F_u to 0.45 F_u to avoid further fractures and to allow for investigation of the cause of the failures. The tension level was reduced on all unbroken rods. If the tension

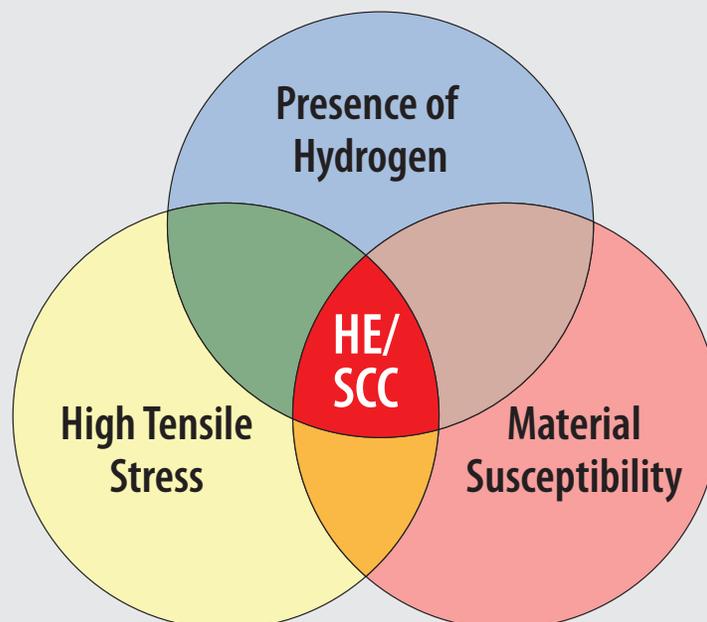
Causes of Hydrogen Embrittlement (HE) or Stress Corrosion Cracking (SCC)

The accompanying Venn diagram shows that when all three conditions apply (i.e., the presence of hydrogen, high tensile stress and a susceptible material), the metallurgical structure of the steel has a higher susceptibility to HE. The diagram also shows that these same conditions can cause a related phenomenon known as Stress Corrosion Cracking (SCC), which will be addressed later in this report.

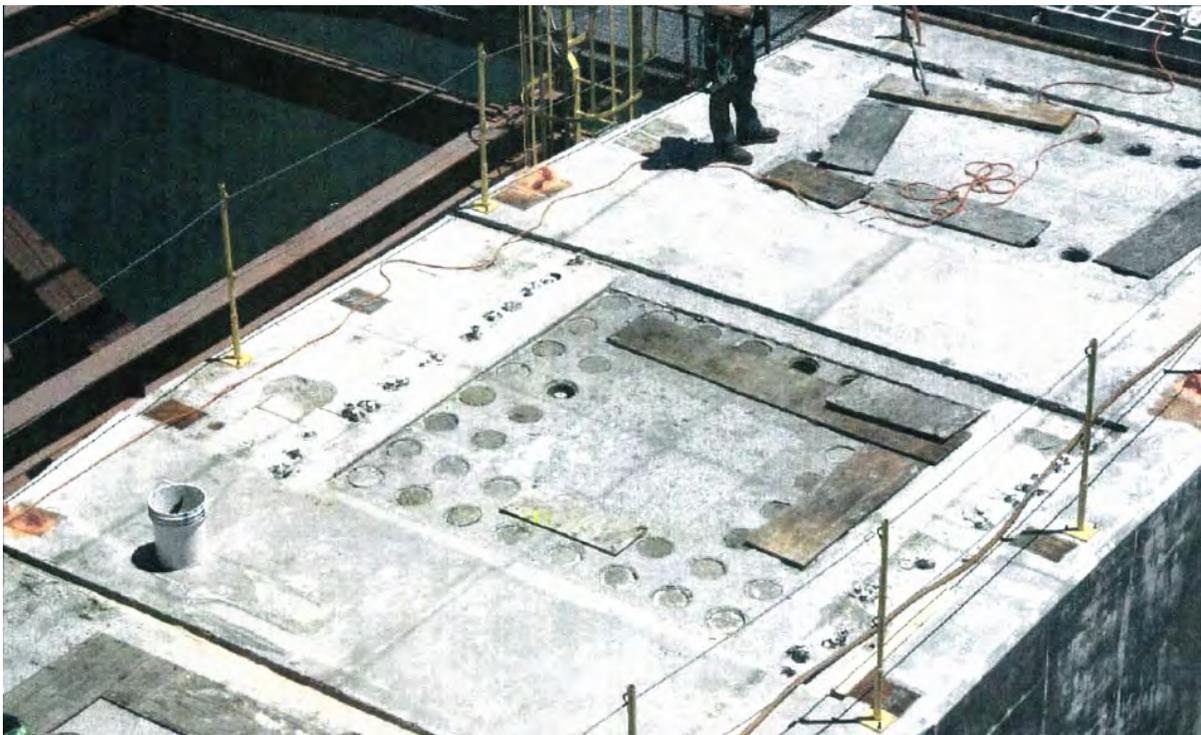
Figure 18 Pier E2 Cap Construction Photograph — Embedded rods are in holes

The rods installed at Pier E2 were manufactured by Dyson in Ohio in 2008, and were installed prior to the final concrete pour on December 5, 2008. These high-strength steel rods were embedded within the pier directly above the columns, and were sitting in ducts for five years before they were tensioned. During this five-year period, water was pumped out of the ducts a number of times at the request of Caltrans. Temporary drainage and sealing arrangements had not prevented the ingress and collection of rainwater, since it had not been anticipated that there would be such an extended period prior to completing the erection and grouting operation at Pier E2. The actual length of time during which water was present in these holes is unknown, but the presence of water may have been a contributing source of hydrogen contamination in the rods (see photo in Figure 18).

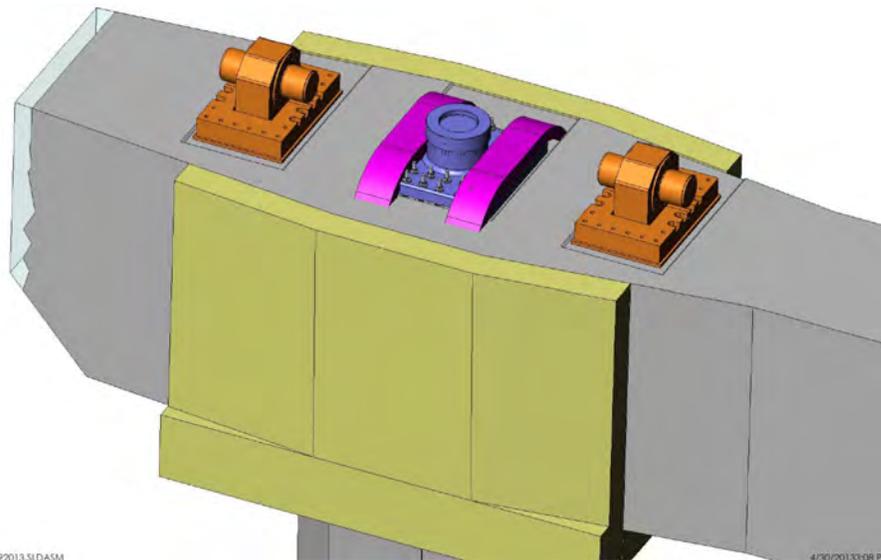
Figure 20 Early Rendering of Option 2 — Steel Saddle

Option 2: Steel Saddle (Figure 20) — This option would secure the lower housing of the shear key with post-tensioning cables that extend over the sides of the cap. The cables would then be encased in a concrete blister outside of the pier cap, minimizing the impact to the cap.

In all cases, the 2008 A354 grade BD rods would be completely abandoned and replaced with equivalent clamping capacity.

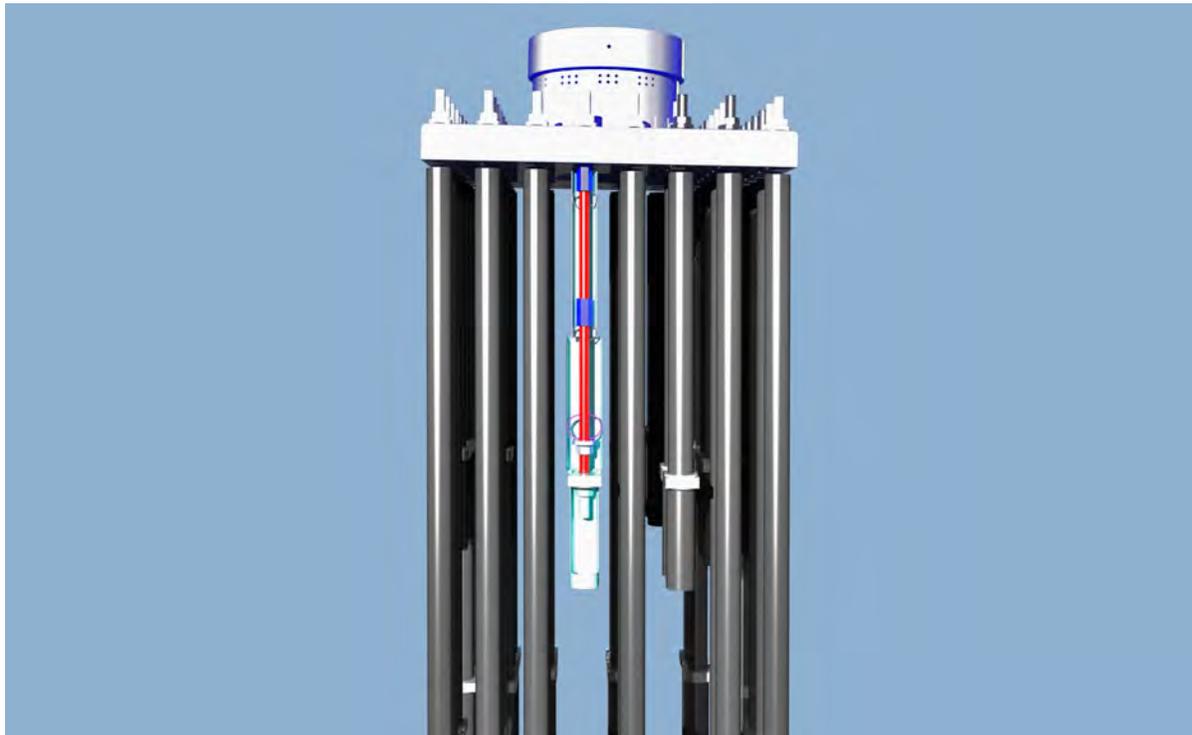
Figure 21 Early Rendering of Option 3 – Post-Tension Tie Down

Option 3: Post-Tension Tie Down (Figure 21) — This option explored the removal of the shear keys so that all the broken and unbroken rods could be replaced with post-tensioning cable anchors. Conceptually, this would require the removal of the unbroken rods, the broken rod remnants and grout with high-precision water jets from the anchorage ducts in Pier E2, and development of a post-tension anchor system for installation at the bottom of the 17-foot-deep ducts.

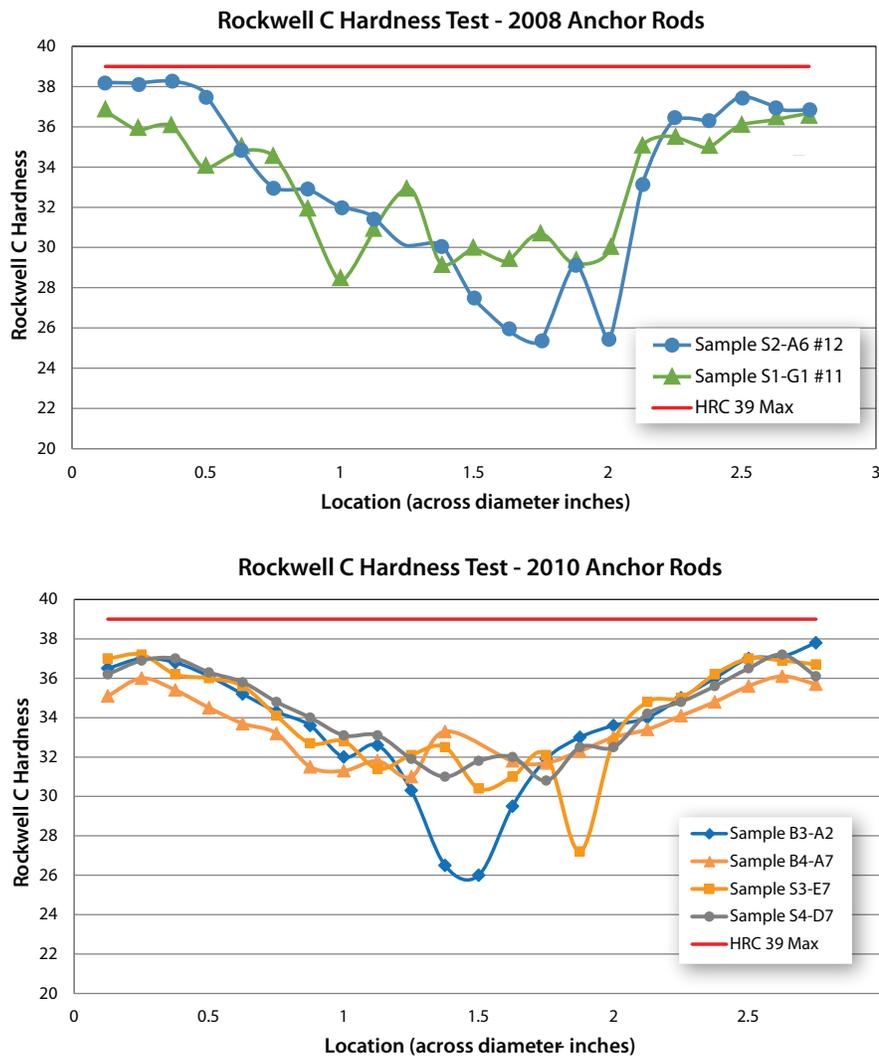
Figure 23 Mechanical Test Comparison 2008 vs. 2010 (Pier E2)

A number of rods were extracted and subjected to an extended test program to determine if hydrogen embrittlement had occurred. These extracted rods were examined extensively and no evidence of hydrogen embrittlement was found. Further the 2010 material properties were substantially better than the 2008 material with homogenous microstructure and improved toughness. The 2008 material failed at a tension level substantially lower than the actual yield strength of the rods, which is evidence of hydrogen embrittlement and lack of toughness. Laboratory testing results for both the 2008 and 2010 rod results are shown in Table 12 and Figure 23.

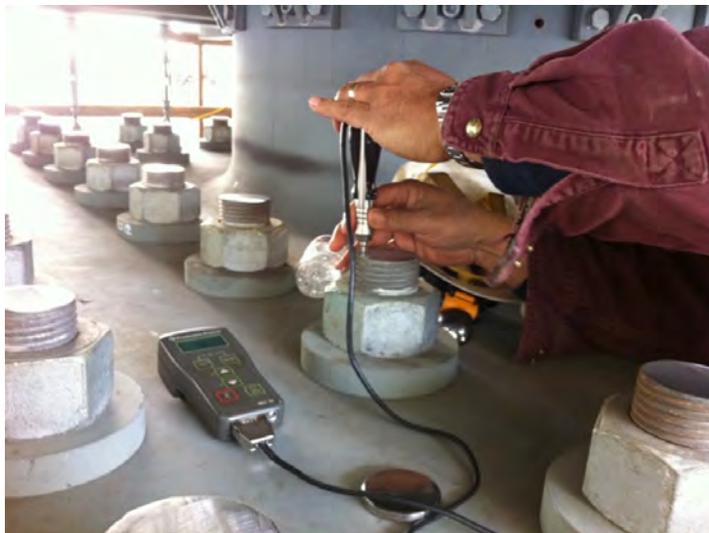
Figure 24 Photograph of Inspector Performing *In-situ* Hardness Test on Bearing Rod

Test I Test I is a test to conduct an *in-situ* hardness test on all accessible A354 grade BD rods and bolts on the SAS Bridge, thereby categorizing the susceptibility of each individual rod relative to hardness and applied stress intensity. The galvanized layer will be ground off the top surface of the rods using a grinder and sand paper. Once the surface is free from oil, grease, dust, rust, and surface coatings, measurements will be taken throughout the rod's diameter using a hardness tester that measures the depth of penetration of an indenter under a large load. A photo of such field testing on Pier E2 is shown below in Figure 24.

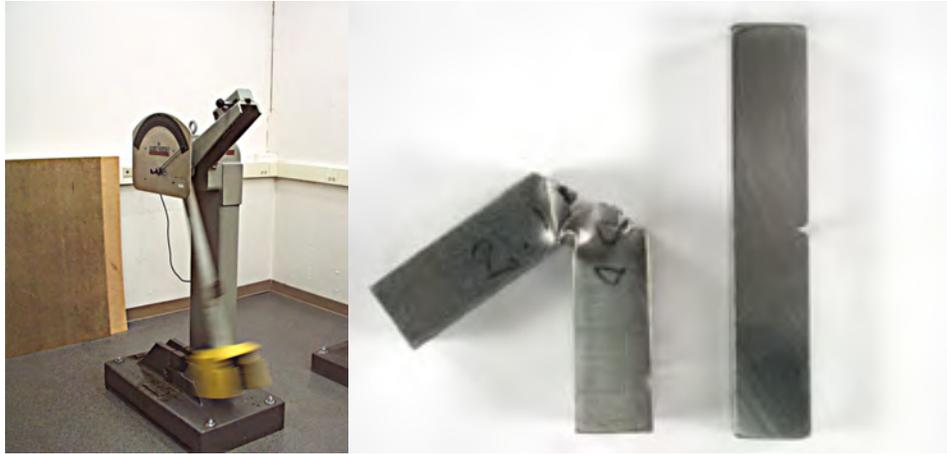
Figure 25 Charpy Toughness Test in Process (left); Tested and Untested Specimens (right)

Test II Test II is to conduct laboratory tests on a selected number of specimens or spares in order to determine a rod's hardness (Rockwell hardness test), toughness (Charpy V-Notch test) and chemical composition (Figure 25). In some locations there are rods installed in the bridge that have an excess or protruding length which, if cut off, could serve as a test specimen in a controlled laboratory environment. There are also some spare rods from the original manufactured lots that are available for laboratory testing.

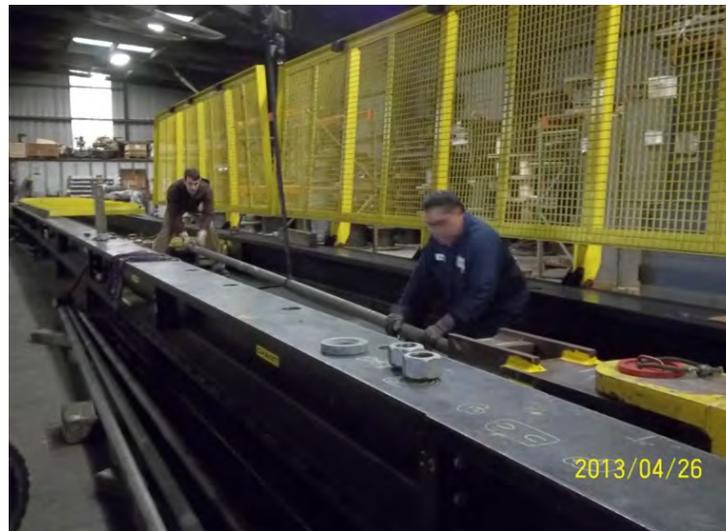
Figure 26 Photograph of Full-Sized Rod Being Placed into Test Rig

Test III Test III is to conduct laboratory testing (full size tension test, coupon tension test, Rockwell C hardness, Charpy, chemistry, fracture analysis) of full-sized rods extracted from the Pier E2 shear key and bearings (Items #2, 3, and 4 in Table 1) and the Tower Anchorage (Item #12 in Table 1). All the other full-sized tests can be performed on spare rods and bolts from the original manufactured lots. Under Test III, rods will be loaded to failure, and the failed rods will be examined and tested to determine their hardness, toughness, mechanical properties, and chemical composition. Figure 26 shows such a full-sized laboratory test underway.

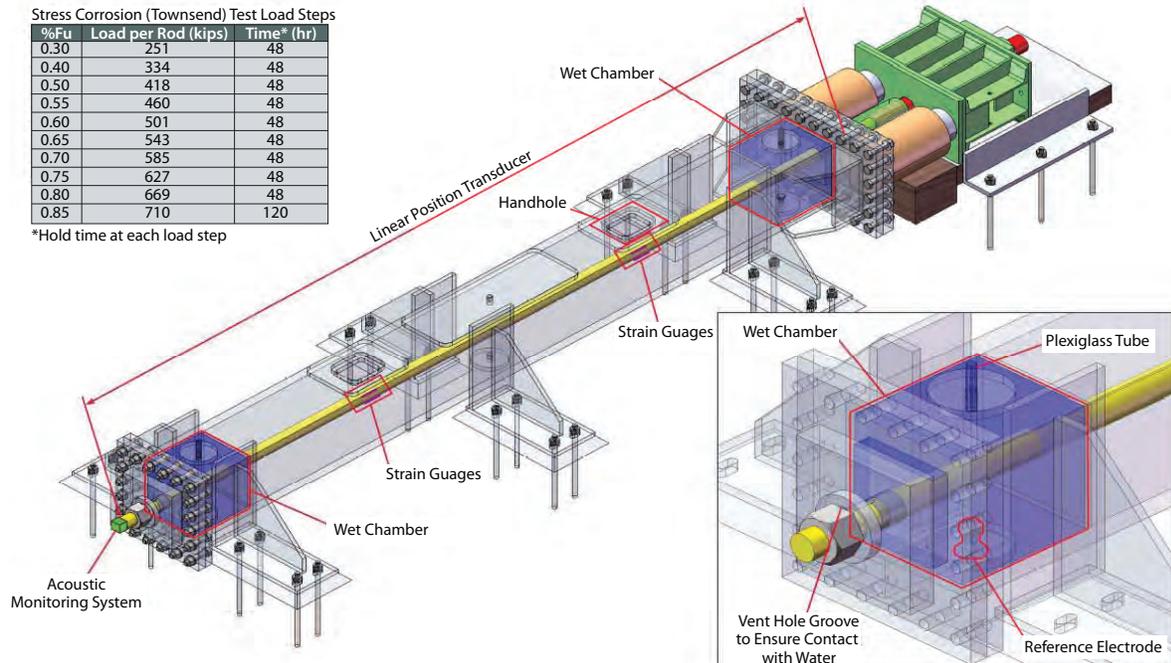
Figure 27 3D Rendering of Stress Corrosion Test Platform for Test IV

Test IV Test IV (Townsend Test) is to conduct an accelerated stress corrosion test which replicates the earlier Townsend research (Figure 27). The results of Test IV will provide the curve against which the results from Tests I, II and III will be plotted and assessed in an updated and completed in the figure in the following section. The sample selection focuses on the rods subjected to the higher stress intensities (i.e., 0.7 Fu) with one additional sample from each diameter size of 2, 3 and 4 inches. Also of interest is whether there is a difference in susceptibility between rolled threads

or cut threads and between galvanized and non-galvanized rods. Determining these differences will also require testing of rods with a diameter of 3½ inches under lower stress intensities.

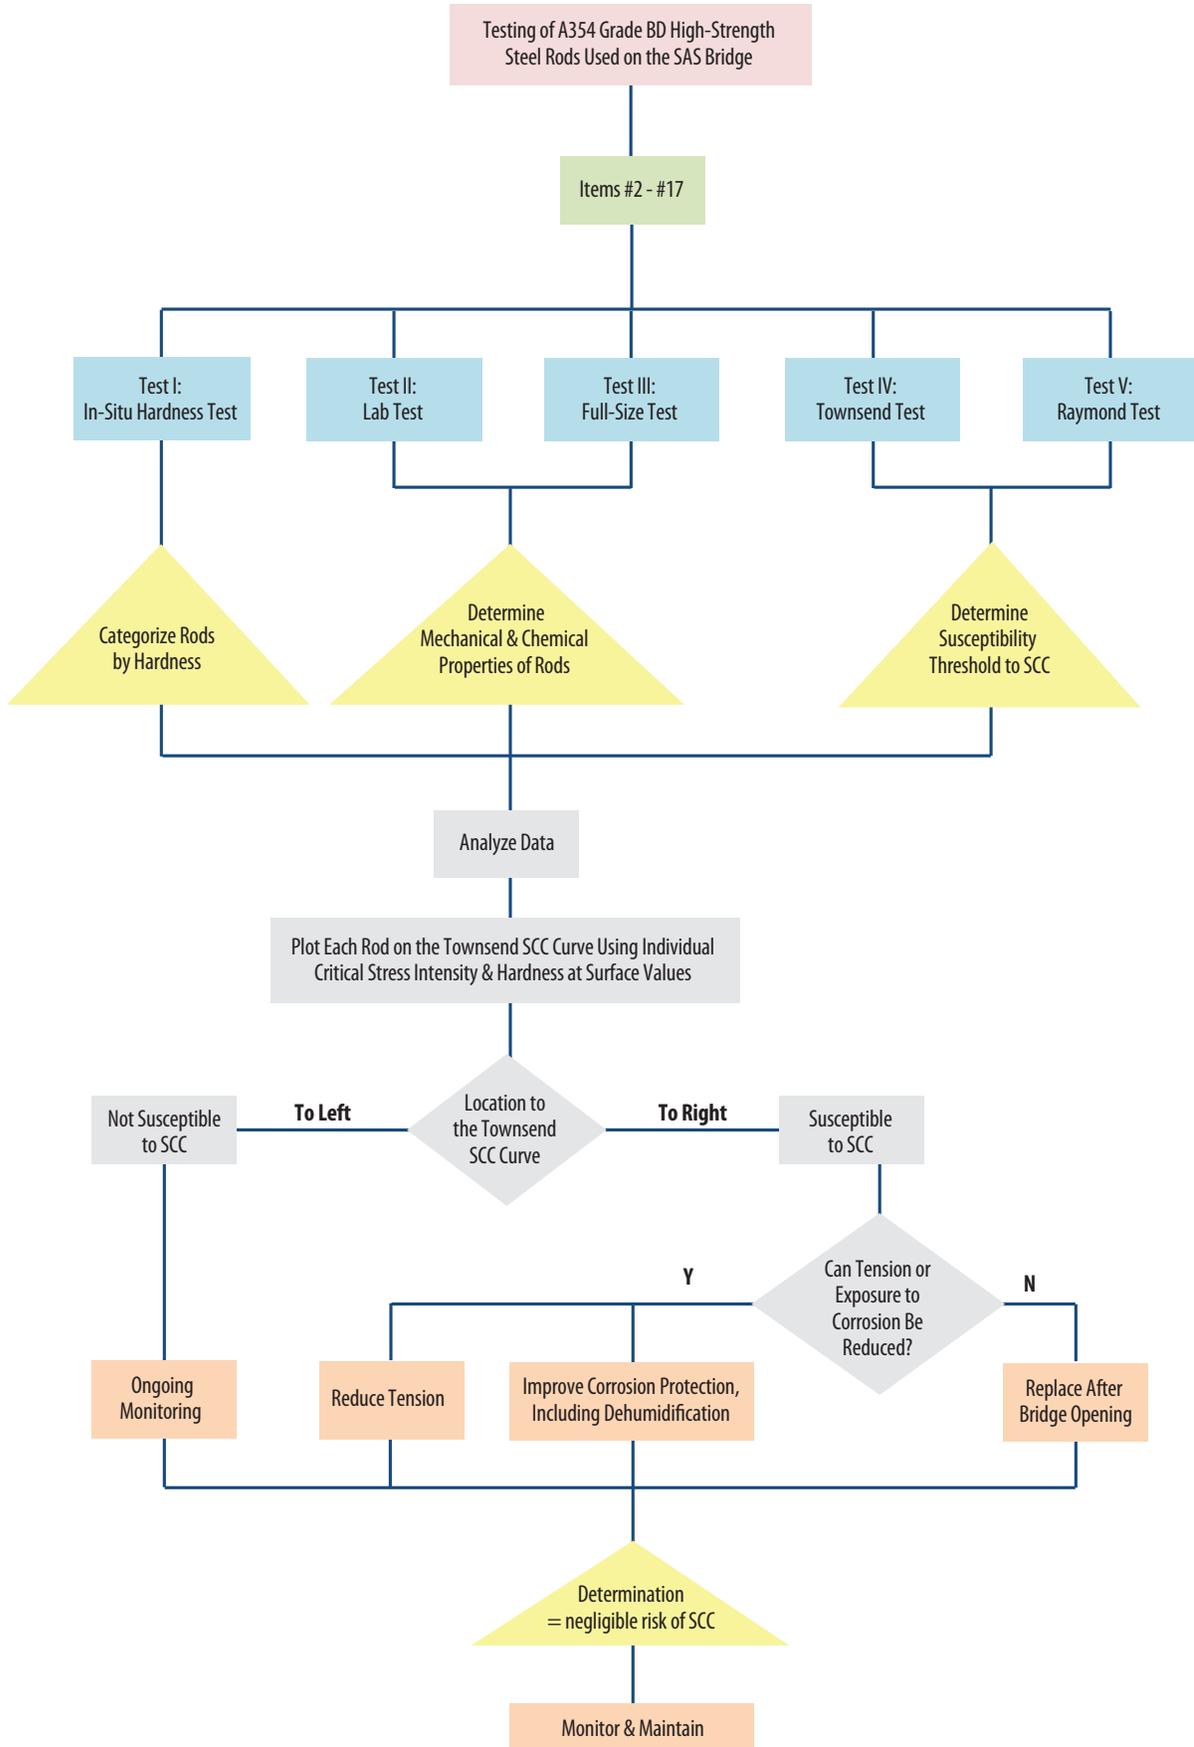
Figure 33 Determination for Susceptibility to Stress Corrosion Cracking

The flowchart displayed in Figure 33 shows the sequence of Tests I through V and at what point it can be determined that a group of rods has “passed the test” of longer-term stress corrosion cracking or, as deemed necessary, must be addressed by the implementation of mitigation measures. The tests are shown in the blue rectangular boxes; mitigating actions in the orange rectangular boxes; and the outcome/determination in the yellow triangle.

Upon completion of all the testing and implementation of mitigating measures as depicted in Figure 33, the risk of hydrogen-associated damage to the metallurgical structure of the high-strength rods will have been addressed for the SAS Bridge. These test results also provide conclusive evidence that the cause of the high-strength rod failures observed in March 2013 from short-term hydrogen embrittlement is isolated to the shear key S1 and S2 anchor rods at the top of Pier E2 manufactured in 2008. This conclusion is further confirmed by the ongoing performance of the remaining rods under varying levels of tension as depicted earlier in Table 9.

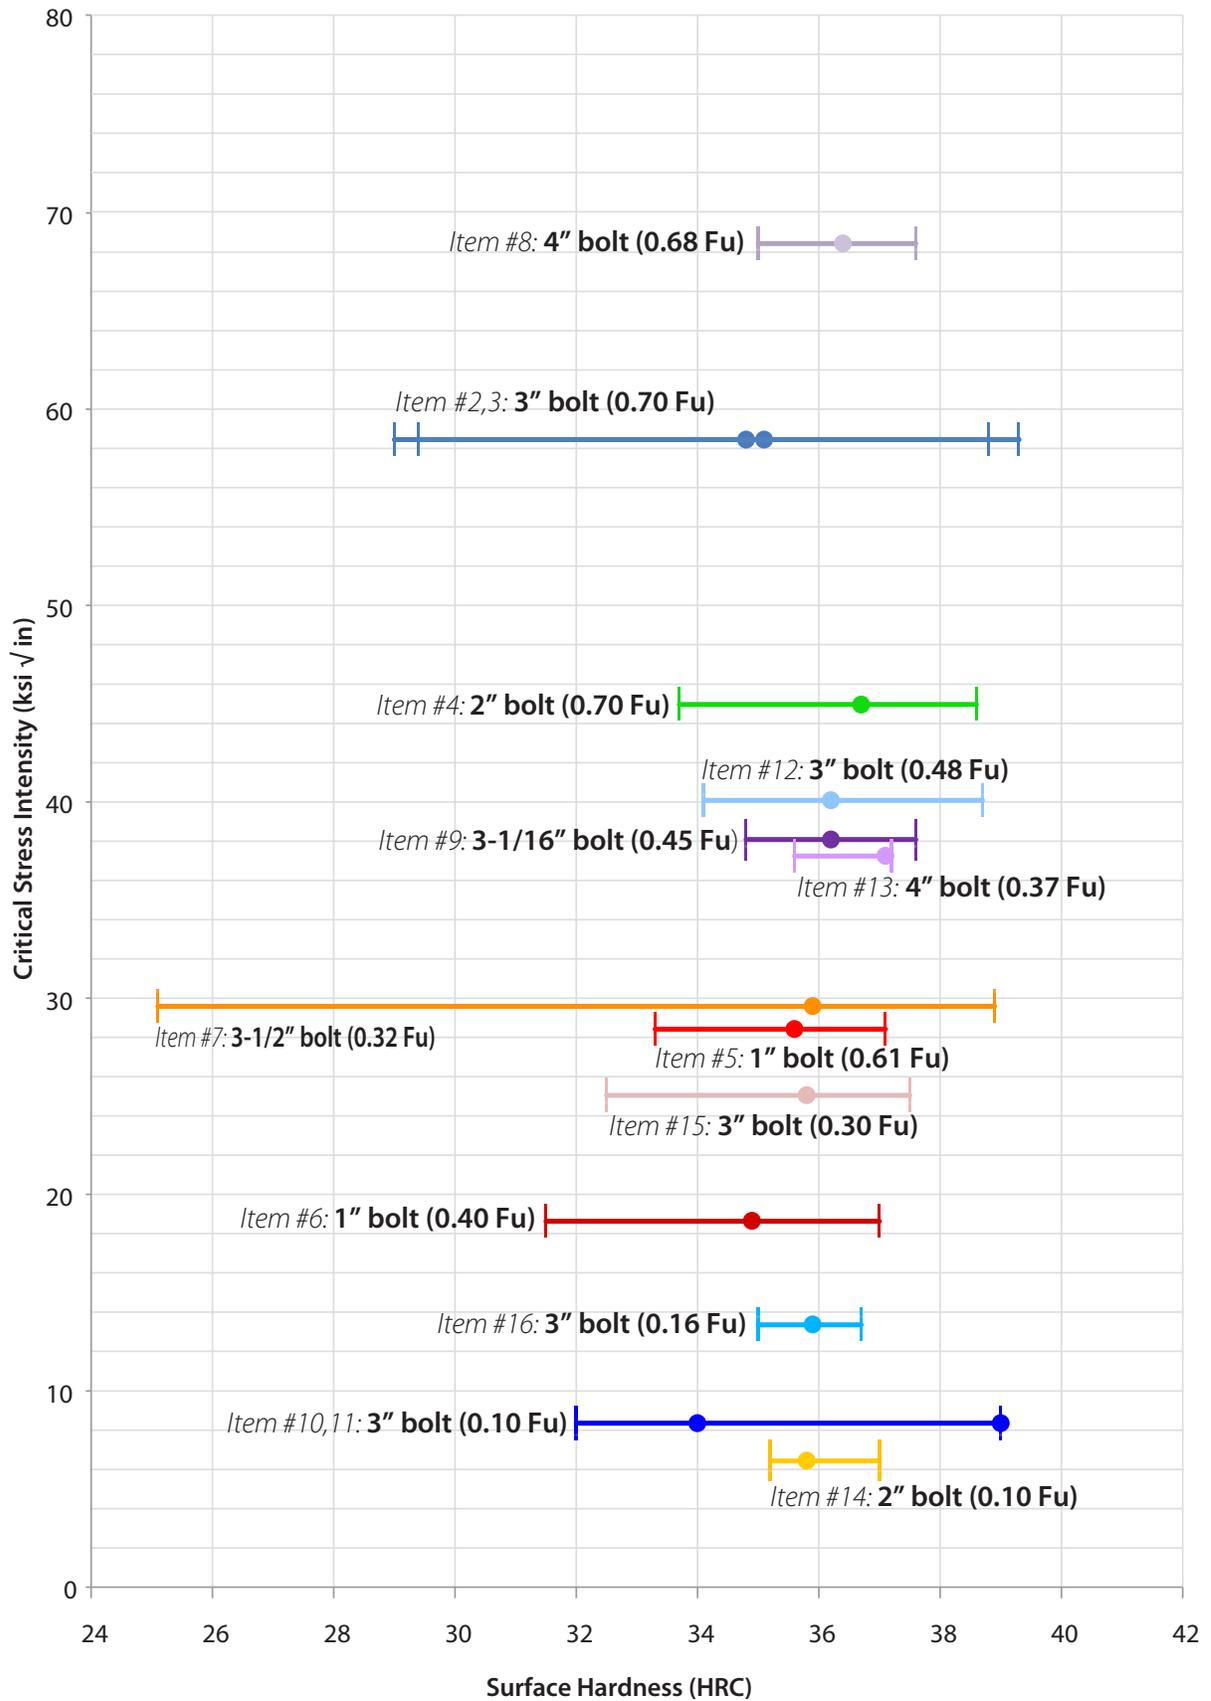
Figure 34 Critical Stress Intensity as Compared to Surface Hardness With *In-situ* Surface Hardness Test Data

As noted earlier, critical to the development of stress corrosion cracking is the tension the rod is placed under, its diameter, threads and the hardness of the material. Individual rods with higher tension levels and hardness levels at, or above, 35 HRC should be further evaluated for risk for stress corrosion cracking, per guidance from Dr. Fisher. Test I results for *in-situ* surface hardness continue to show varying hardness levels across all tested rods. These results are plotted in Figure 34.

Upon completion of Test IV later this summer, a stress corrosion cracking susceptibility curve for the A354 Grade BD rods can be plotted on the critical stress intensity graph shown in Figure 34, displaying Critical Stress Intensity versus Surface Hardness. As described earlier, when the stress corrosion cracking susceptibility curve is included in Figure 34, in general, those rods plotted to the right of the curve will exhibit greater susceptibility to stress corrosion cracking over time. Conversely, rods plotted to the left of the curve are unlikely to be susceptible to stress corrosion cracking.

In regards to longer-term stress corrosion cracking, there are a number of rods that exhibit surface hardness that is in excess of 35 HRC, a point at which there is increased risk for stress corrosion cracking under sustained high tension. However, based on the tests, these rods also exhibit better metallurgical uniformity and improved toughness. Further, many of the remaining rods are not subject to high sustained tension levels or are located in dehumidified or sealed areas that provided additional corrosion protection. Further, stress corrosion testing is underway as part of Tests IV and V that will provide important data for further analysis and remediation of the rods. A summary of findings based on the material properties obtained from Tests I through III (unless otherwise noted) is contained in Table 13.
